# THE EDAIF TOWER

## Investigation Report (Final)

### **PARTIAL COLLAPSE OF MEZZANINE FLOOR OF EDAIF TOWER – REQUEST FOR STRUCTURAL INVESTIGATION**

**December 2015**

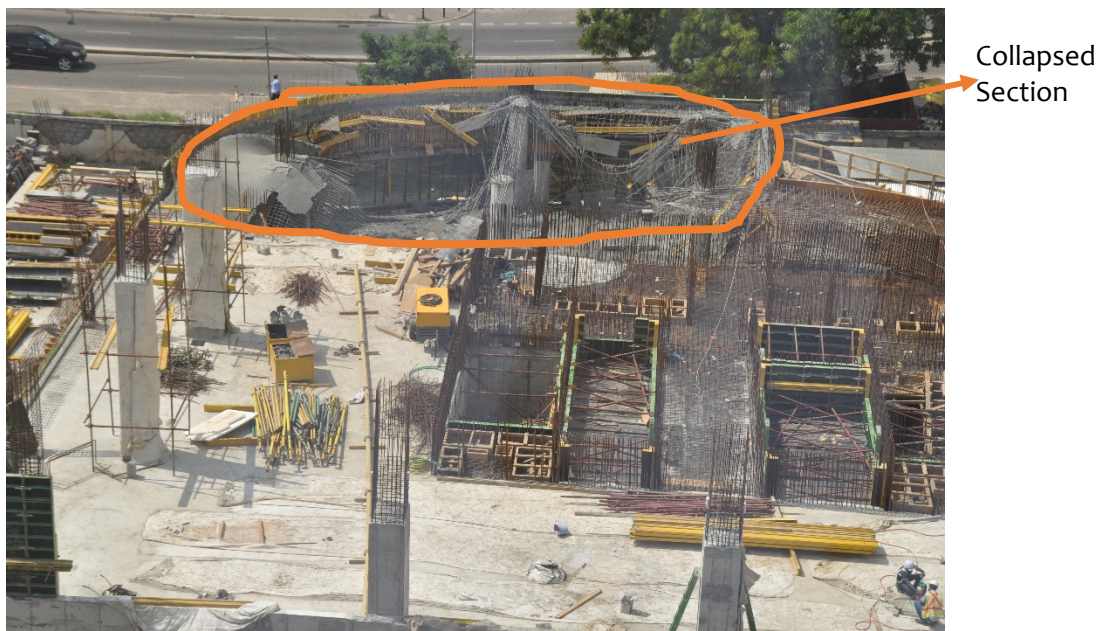
**Figure 1-1: View of Work to date**

During placement of concrete on a section of the Mezzanine floor on Sunday, November 22<sup>nd</sup> 2015, at 1:15pm an incident occurred where the section being worked on collapsed causing one fatality and other casualties. This incident recorded ten (10) persons injured and one (1) person dead with damage to other properties and materials on site. Figure 1-2 shows the completed works to date and the collapsed section.

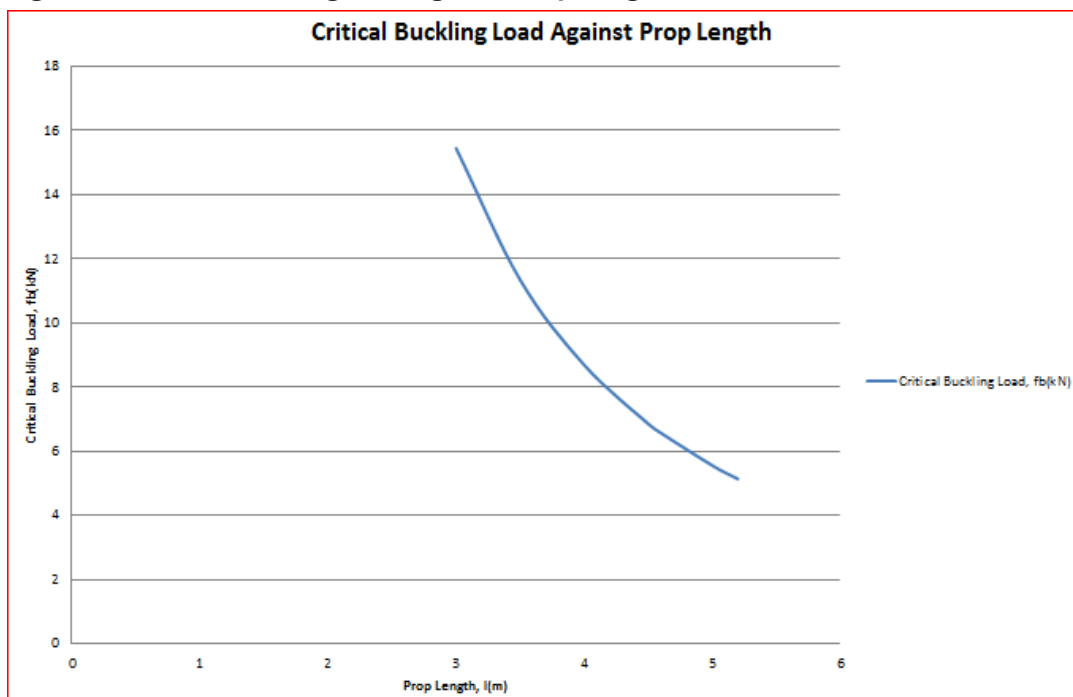
**Figure 3-1: Critical Buckling Load against Prop Length**

Figure 3-1 is a graph showing the relationship between the critical buckling load and the length of the steel prop. The graph is based on data from **Error! Reference source not found..** The relationship is an inversely proportional one and as such, the load carrying capability of the prop reduced rapidly from 1.5tonnes stated by the supplier once the height of the prop increased. For normal construction where the floor-to-floor heights rarely exceed 3.5m, 3m lengths of props can easily be used to support the quoted load of the prop.

Several calculations have been advanced that established that due to the length of the props, failure by buckling was inevitable. The 1.5tonnes as a capacity for the props to be used at 5.2m height with a diameter of 64mm is misleading. A column of 5.2m height and 64mm diameter should be analysed as a slender column which fails in buckling. Buckling should therefore be used to determine the capacity of the props.

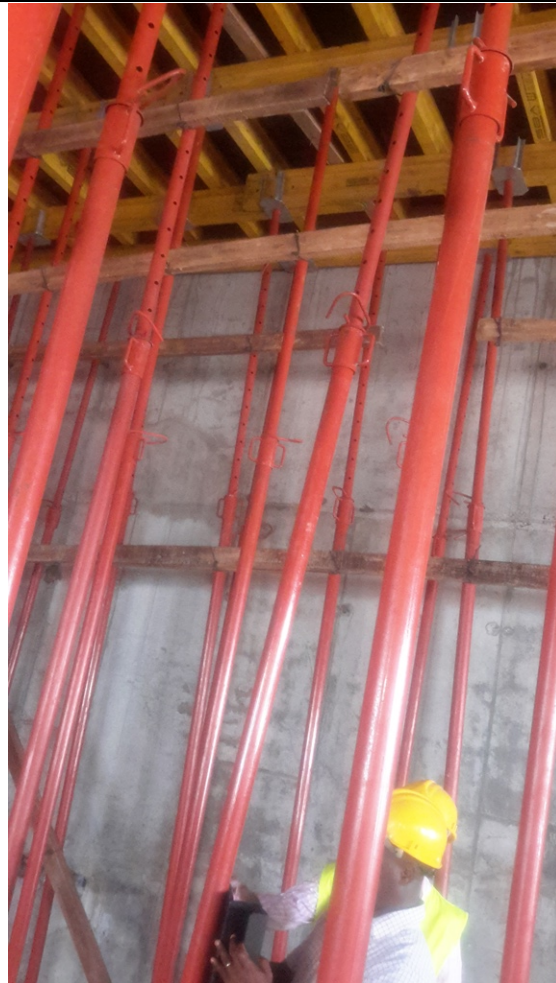
**Figure 3-3: Props severely out of Plumb**

In the case of the EDAIF Tower, it was observed that the bracing was virtually non-existent. Figure 3-7Figure 3-8 are pictures that show the various attempts to brace the props. Several props were out of plumb by more than  $1.5^\circ$ . The prop spacing was also not uniform.

The investigations revealed that the adjustable steel props used for the construction of the mezzanine floor of the EDAIF Tower were improperly fixed. The props were out of plumb, not properly braced and irregularly spaced. This implies that there were varying loads on each prop. Safe Working Load tables provided by many manufacturers and formwork standards show the maximum load that should be imposed on each prop.

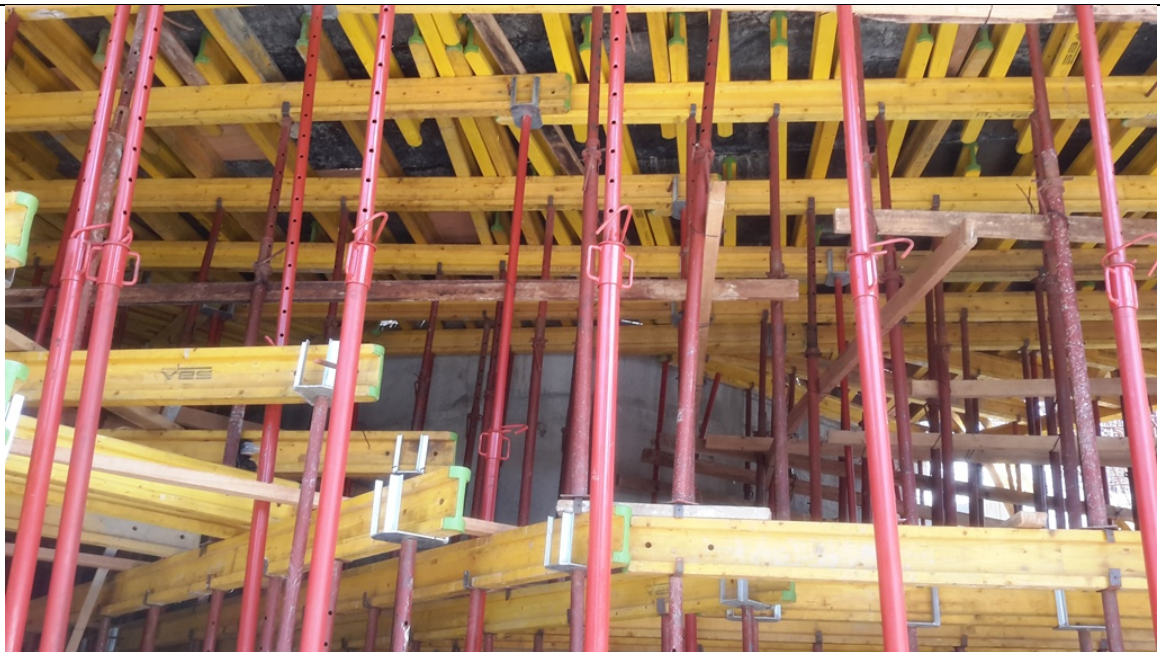
Figure 3-6: Props supported off Joists

The Structures team also noted that the props were not properly fixed in place: non-verticality, inadequate and improper bracing and irregular spacing. It was instructive to note that the use of timber joists secured by binding wire was a poor attempt at bracing the falsework and offered very little resistance to the collapse of falsework. Certain props were supported off other timber joists that were themselves supported on props.

The original arrangement of the props resulted in the base being considered fixed and the top being free. This particular arrangement of props with props supported on joists constituted a hinge that presents a condition that was not allowed for in the original design of the prop.

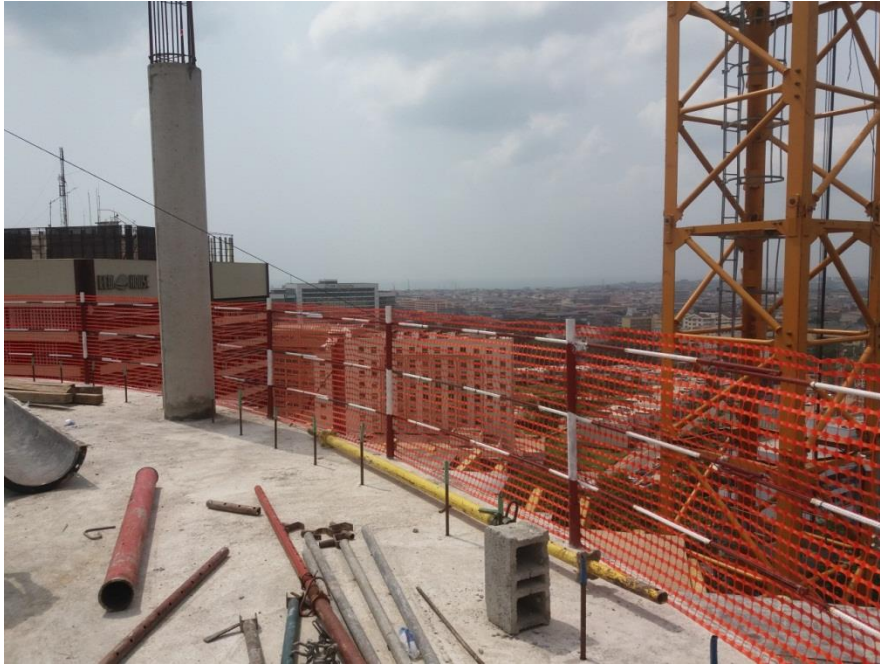
**Figure 13:** Fabricated steel rods painted red and white, used as barriers on the edge of the floor slab with red net around them to protect workers from falling

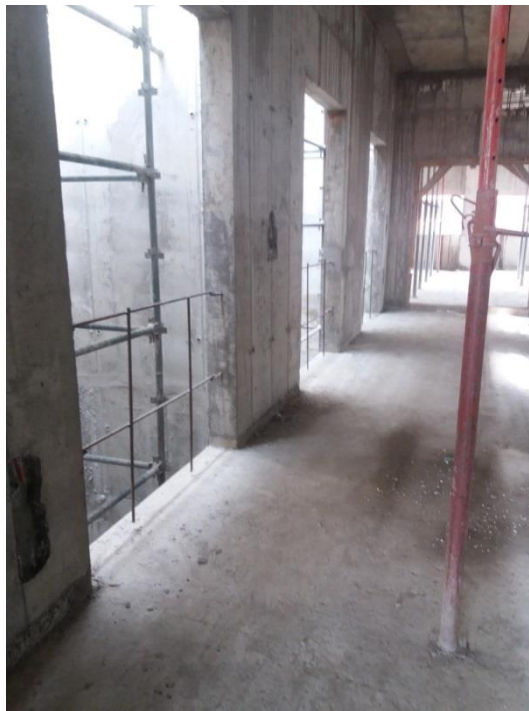
**Figure 14:** Fabricated steel rods used as barriers around floor holes to protect workers from falling

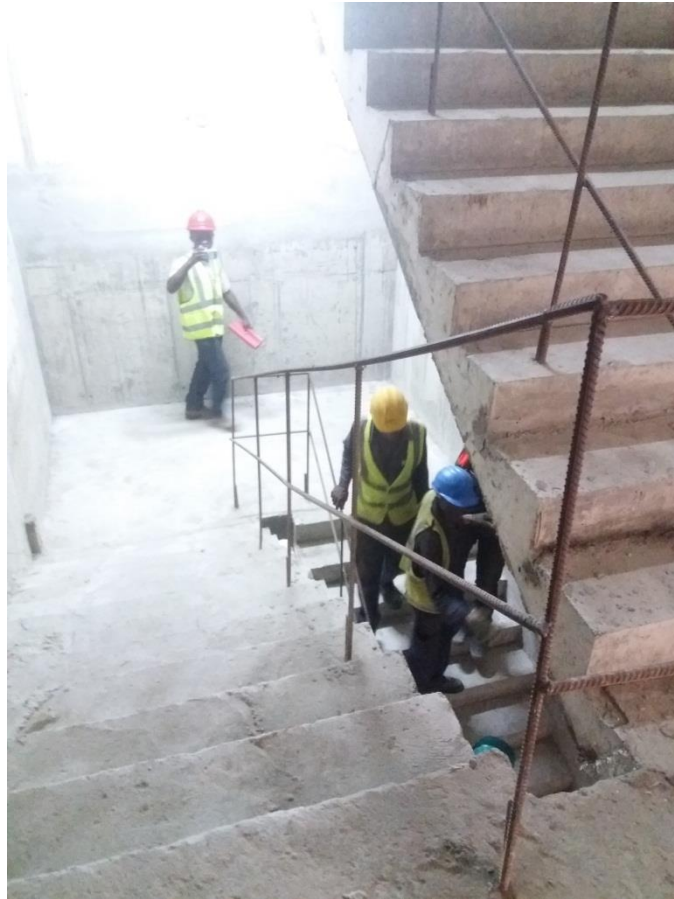
**Figure 15:** Fabricated steel rods used as handrail and barrier for the staircase to protect workers from falling

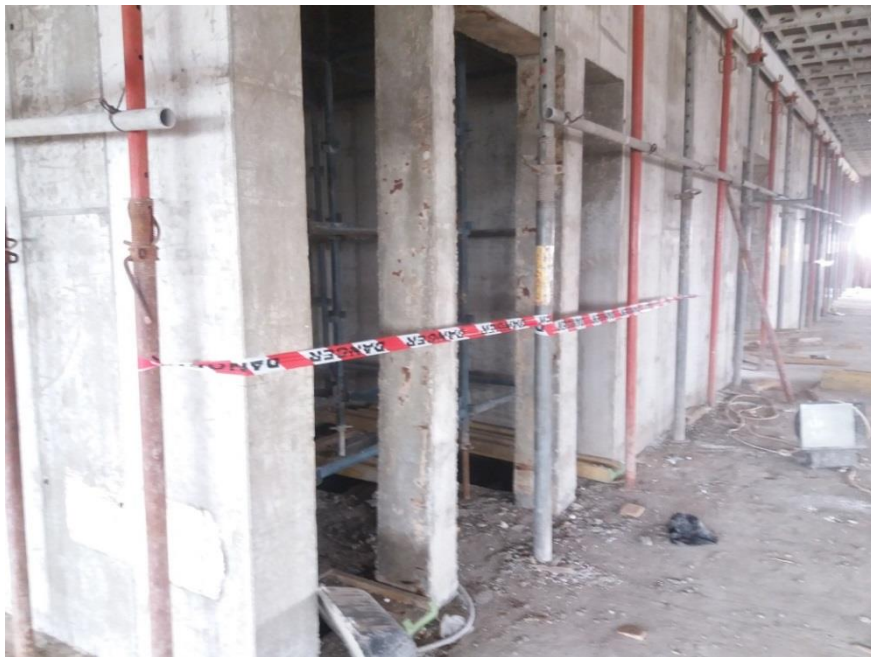
**Figure 16:** Caution and warning tape wrapped around a floor hole to warn workers of the possible danger.

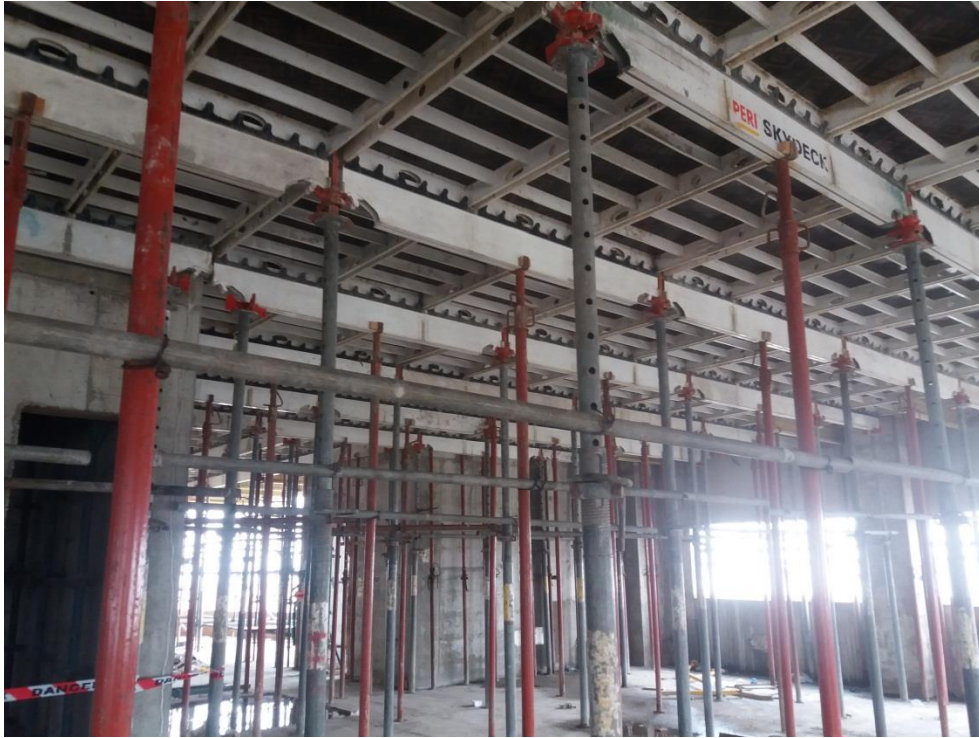
**Figure 17:** Slab formwork adequately supported by solid steel props.

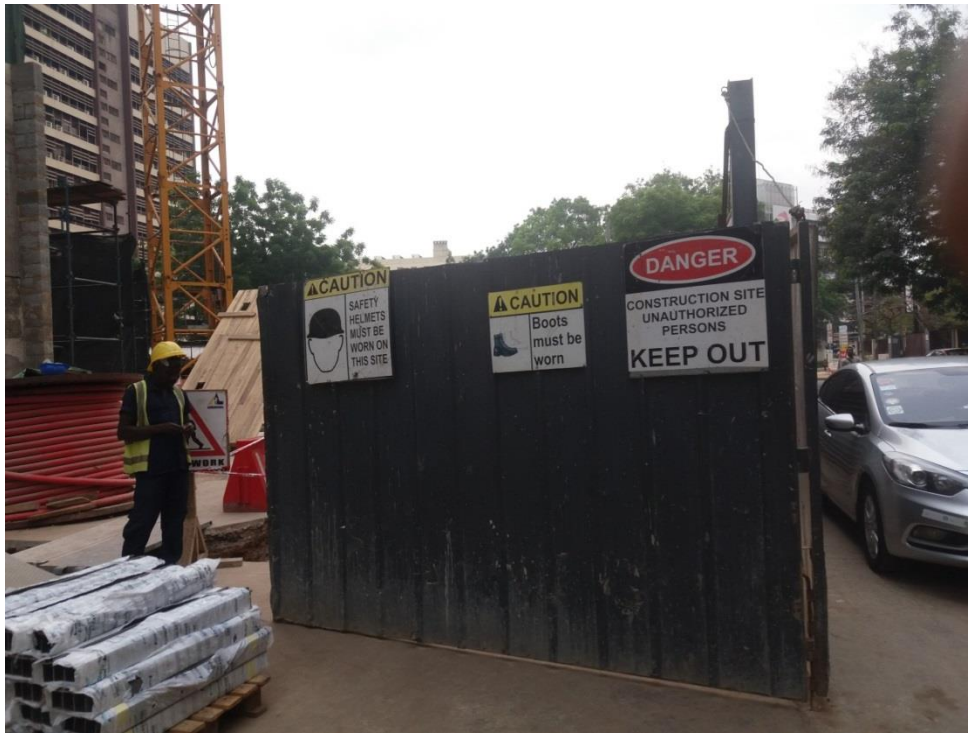
**Figure 21:** Signages posted on the entrance gate to remind workers to wear their personal protective equipment always on site.

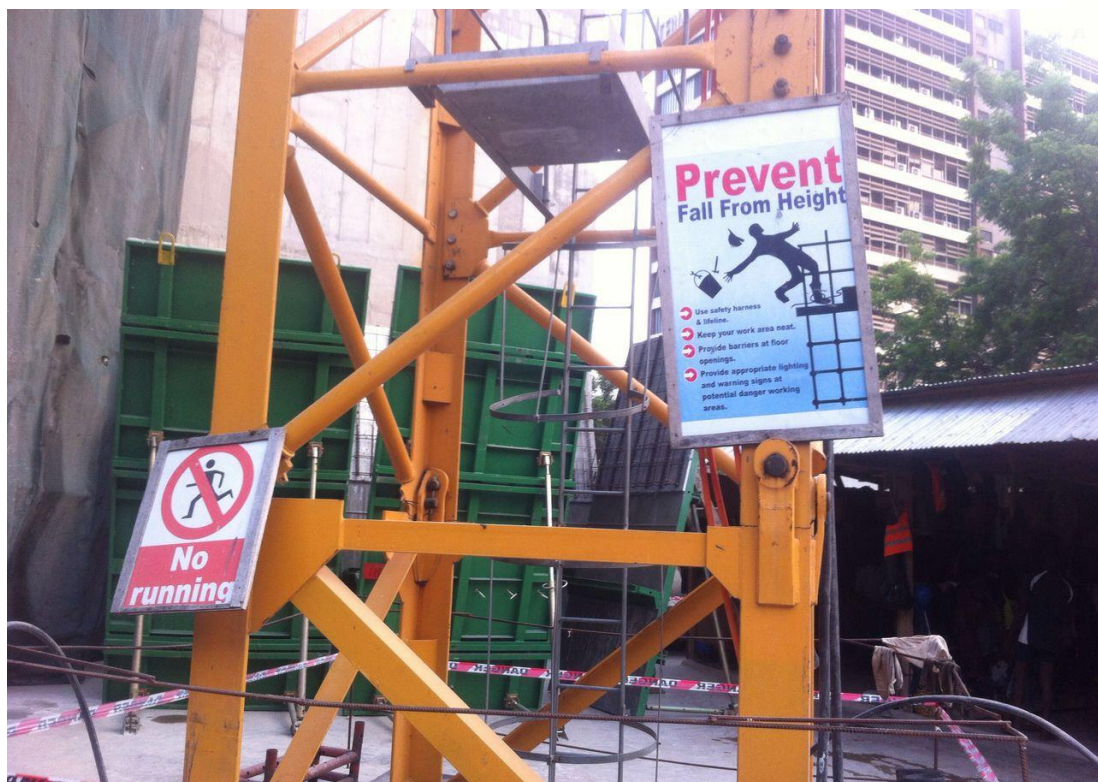
**Figure 22:** Signages posted on a crane stand to restrain workers from running on site and how to prevent falling from heights.
