# THE EDAIF TOWER

## Investigation Report (Final)

### **PARTIAL COLLAPSE OF MEZZANINE FLOOR OF EDAIF TOWER – REQUEST FOR STRUCTURAL INVESTIGATION**

**December 2015**

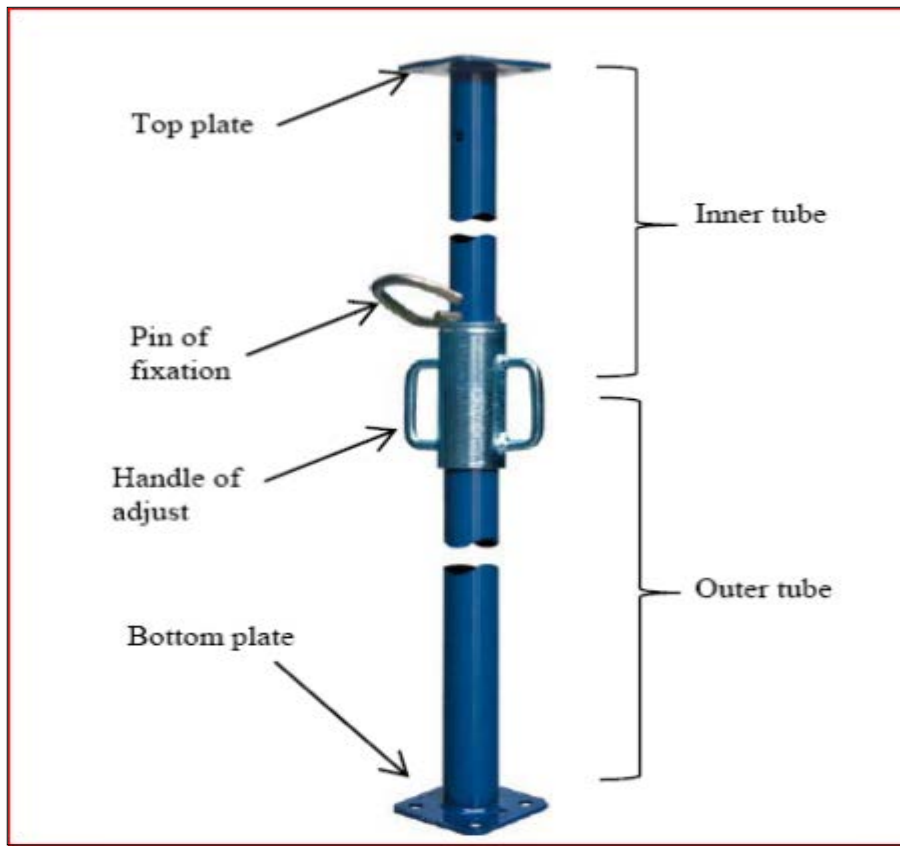
**Figure 3-2: Parts of a Steel Prop**

Figure 3-2 is a picture of a typical adjustable steel prop with the various parts well labelled. When fixing adjustable steel props, it was the expectation of the members of the Structures Team that the props would first be adjusted to a height reasonably close to the fixing height. The *pin of fixation* would then be slotted into the appropriate opening to lock the two parts of the prop together. The prop would then be positioned properly and steps taken to ensure that the prop is not out of plumb, i.e. truly vertical. Subsequently, the *handle of adjustment* would be turned to adjust the height of the prop till the top plate is at the correct level. In cases where the height of the props exceeds  $3\text{m}$ , it is conventional to brace the props adequately to ensure safety.

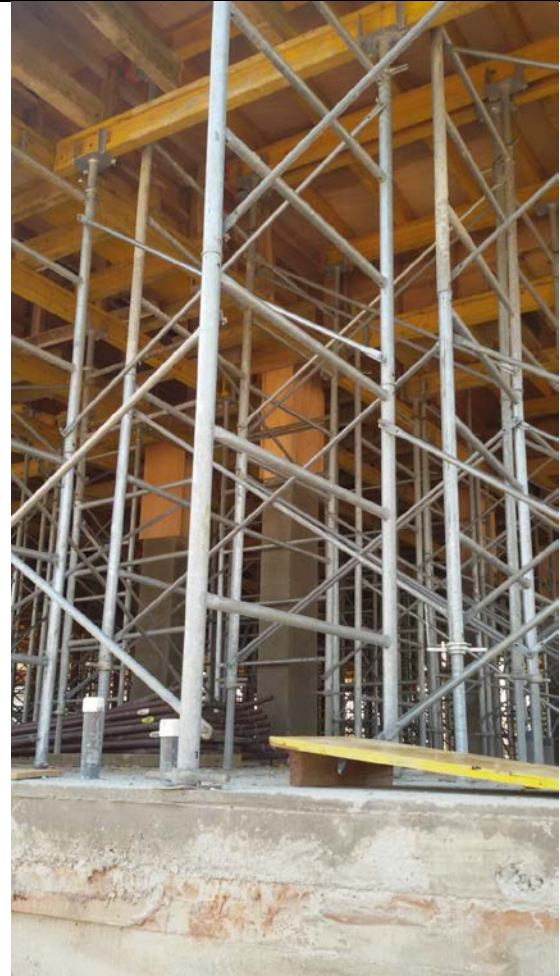
**Sample of Adequately braced Falsework**

In the case of the EDAIF Tower, it was observed that the bracing was virtually non-existent. Figure 3-7Figure 3-8 are pictures that show the various attempts to brace the props. Several props were out of plumb by more than  $1.5^\circ$ . The prop spacing was also not uniform.

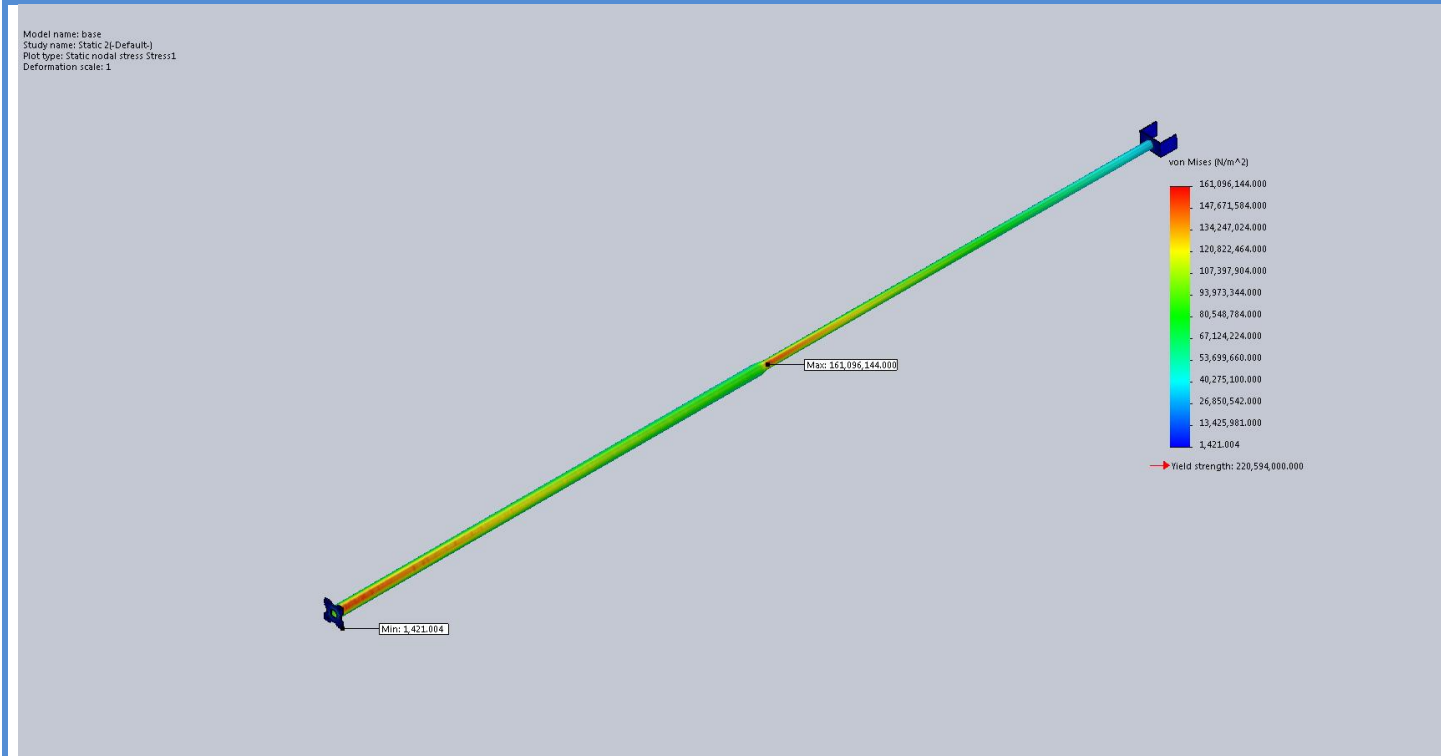
base-Static 2-Stress-Stress1

| Name | Type | Min | Max |
|---|---|---|---|
| Stress1 | VON: von Mises Stress | 1421 N/m^2<br>Node: 12424 | 1.61096e+008 N/m^2<br>Node: 1189 |

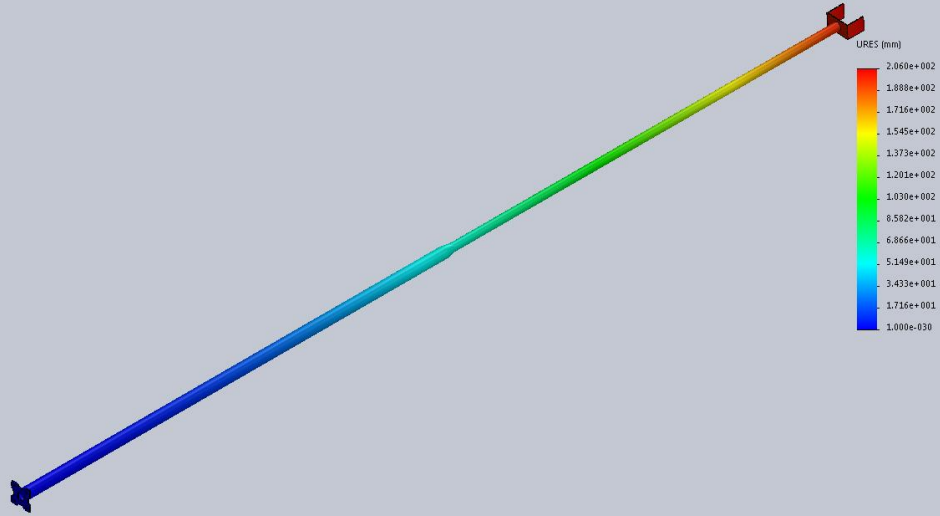
base-Static 2-Displacement-Displacement1

| Name | Type | Min | Max |
|---|---|---|---|
| Displacement1 | URES: Resultant Displacement | 0 mm<br>Node: 4421 | 205.97 mm<br>Node: 7699 |

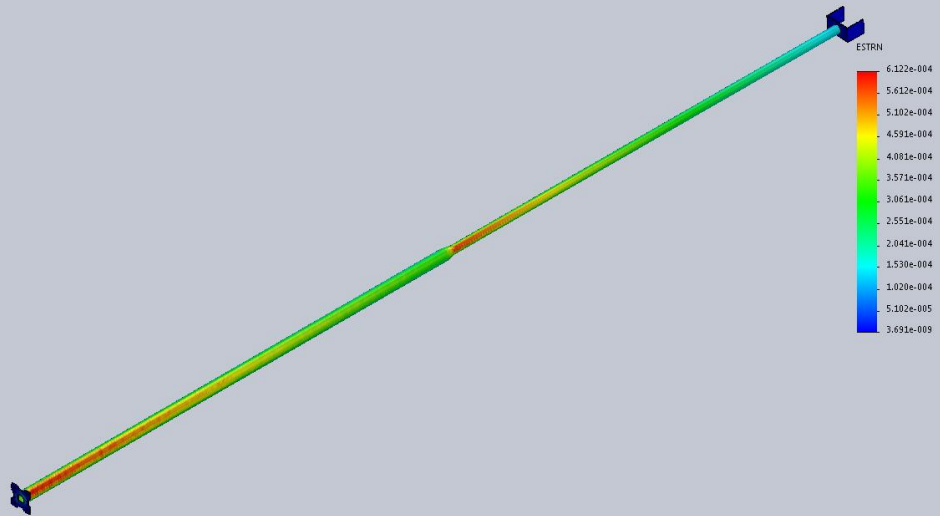
base-Static 2-Strain-Strain1

| Name | Type | Min | Max |
|---|---|---|---|
| Strain1 | ESTRN: Equivalent Strain | 3.69052e-009<br>Element: 15545 | 0.000612184<br>Element: 20067 |

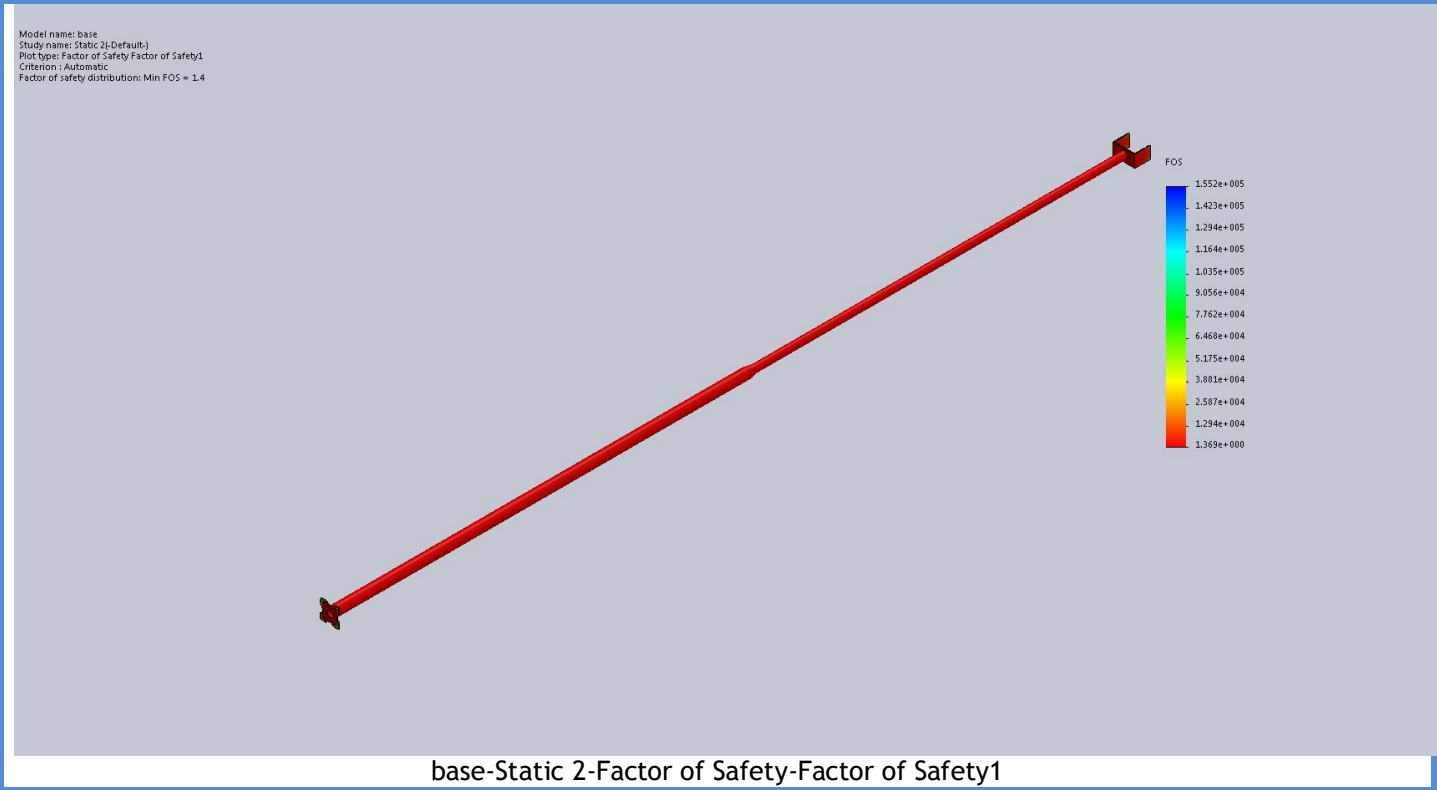
| Name | Type | Min | Max |
|---|---|---|---|
| Factor of Safety1 | Automatic | 1.36933<br>Node: 1189 | 155238<br>Node: 12424 |

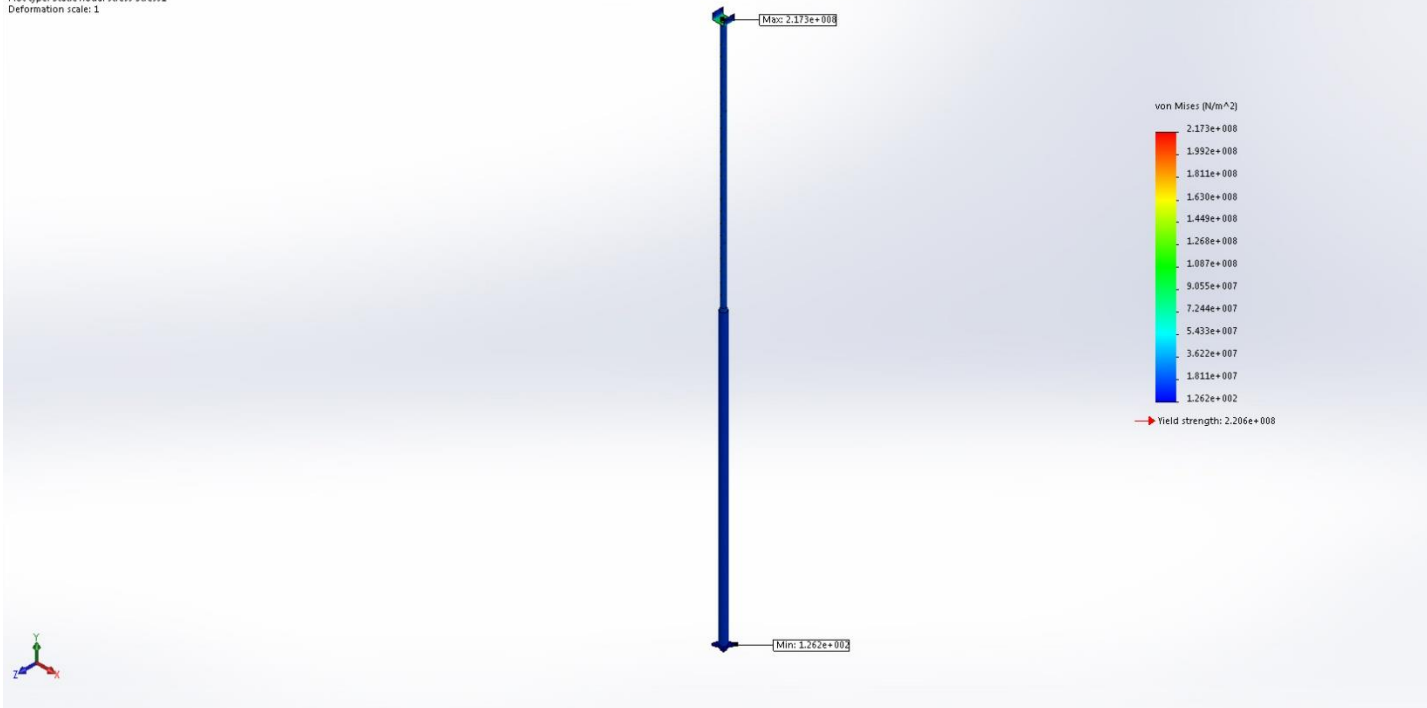
STAND-Static 2-Stress-Stress1

| Name | Type | Min | Max |
|---|---|---|---|
| Stress1 | VON: von Mises Stress | 126.224 N/m <sup>2</sup><br>Node: 26871 | 2.17331e+008 N/m <sup>2</sup><br>Node: 59011 |

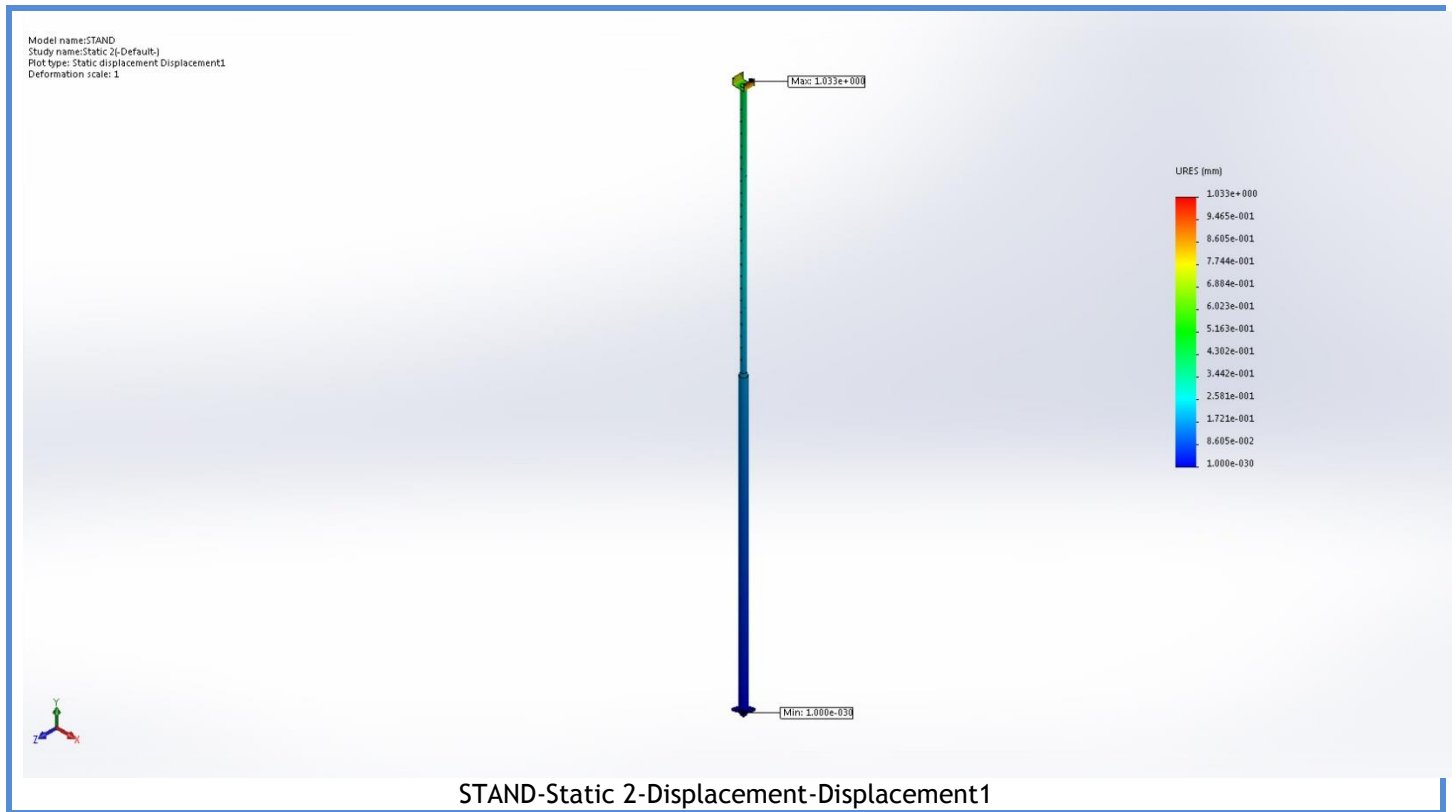
| Name | Type | Min | Max |
|---|---|---|---|
| Displacement1 | URES: Resultant Displacement | 0 mm<br>Node: 26378 | 1.03259 mm<br>Node: 58916 |

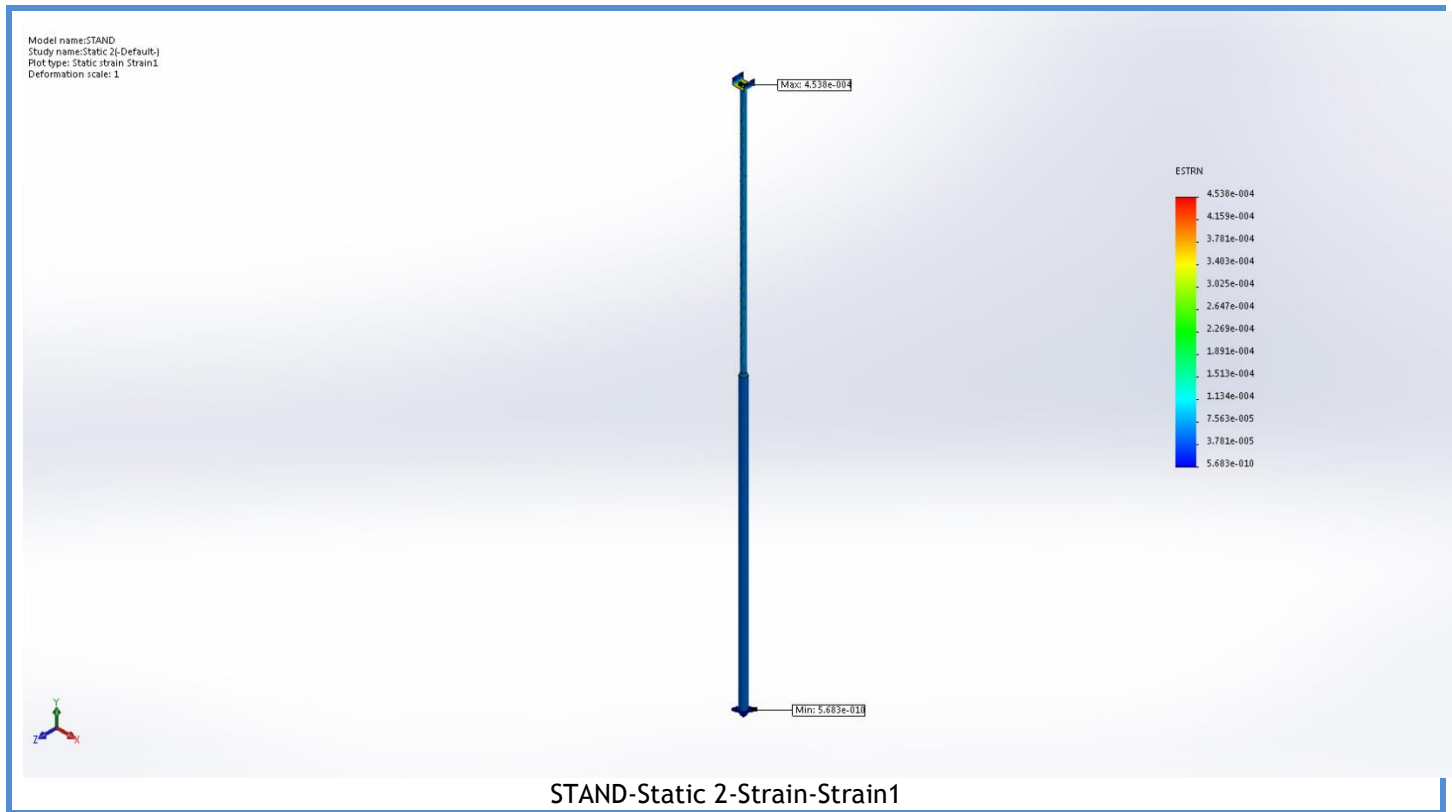
| Name | Type | Min | Max |
|---|---|---|---|
| Strain1 | ESTRN: Equivalent Strain | 5.68278e-010<br>Element: 13371 | 0.000453761<br>Element: 29339 |

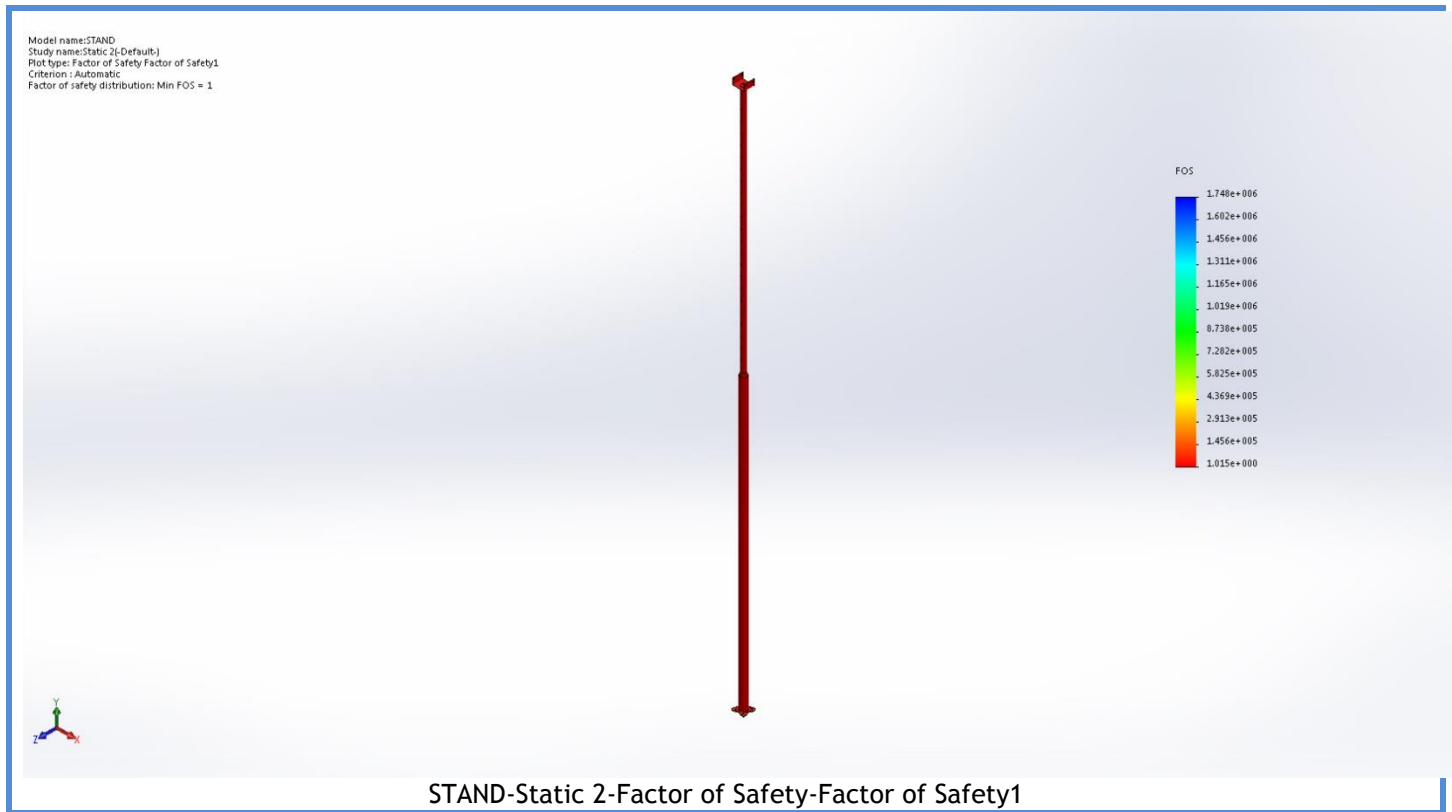
| Name | Type | Min | Max |
|---|---|---|---|
| Factor of Safety1 | Automatic | 1.01501<br>Node: 59011 | 1.74764e+006<br>Node: 26871 |

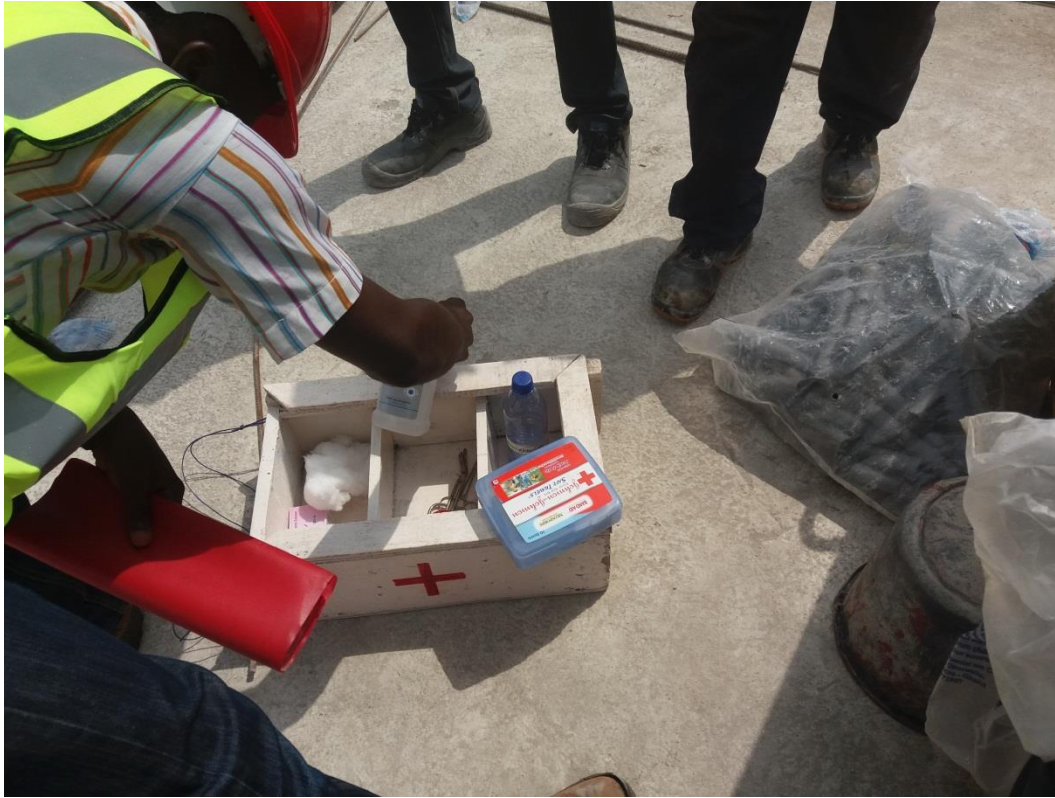
**Figure 18:** First Aid box with medical tools and medicine in it located in the store room

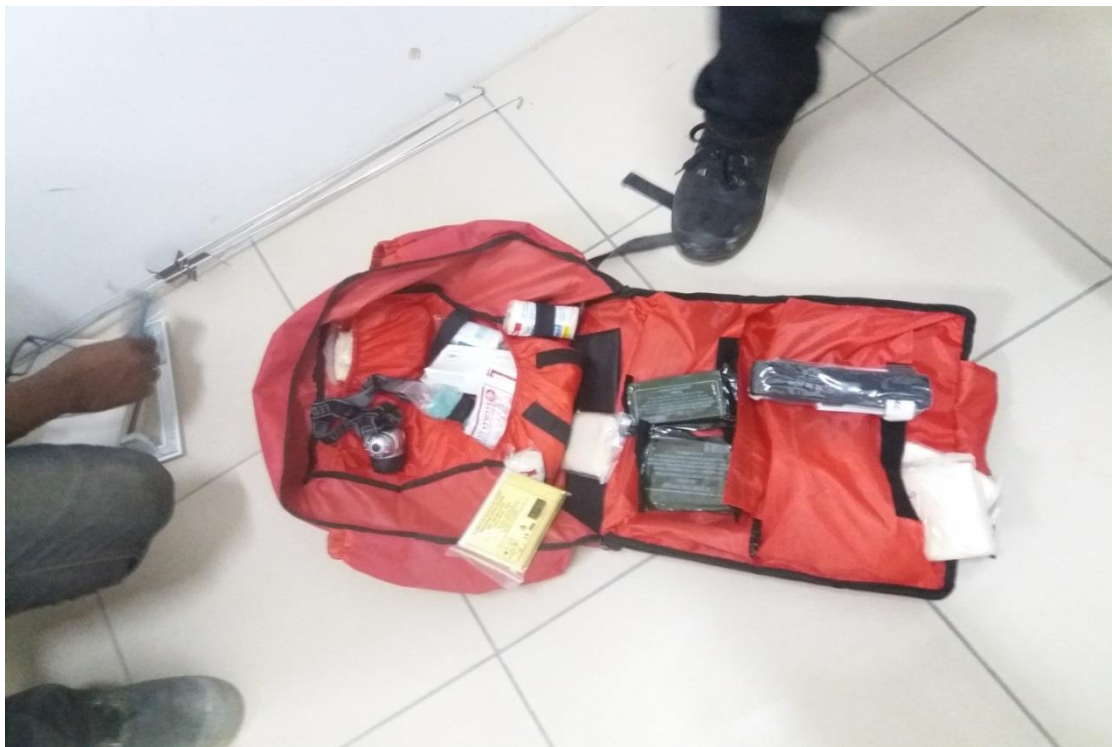
**Figure 19:** First Aid box with the appropriate materials and tools located in one of the working areas of the site.
